Kinder Morgan Linnton Terminal River Bank Erodability Assessment

PREPARED FOR: Kinder Morgan Liquids Terminals LLC
PREPARED BY: Todd Cotten/CH2M HILL
COPIES: Keith Sheets/CH2M HILL
Eric Aronson/CH2M HILL
Jeff Gentry/CH2M HILL
DATE: November 15, 2010

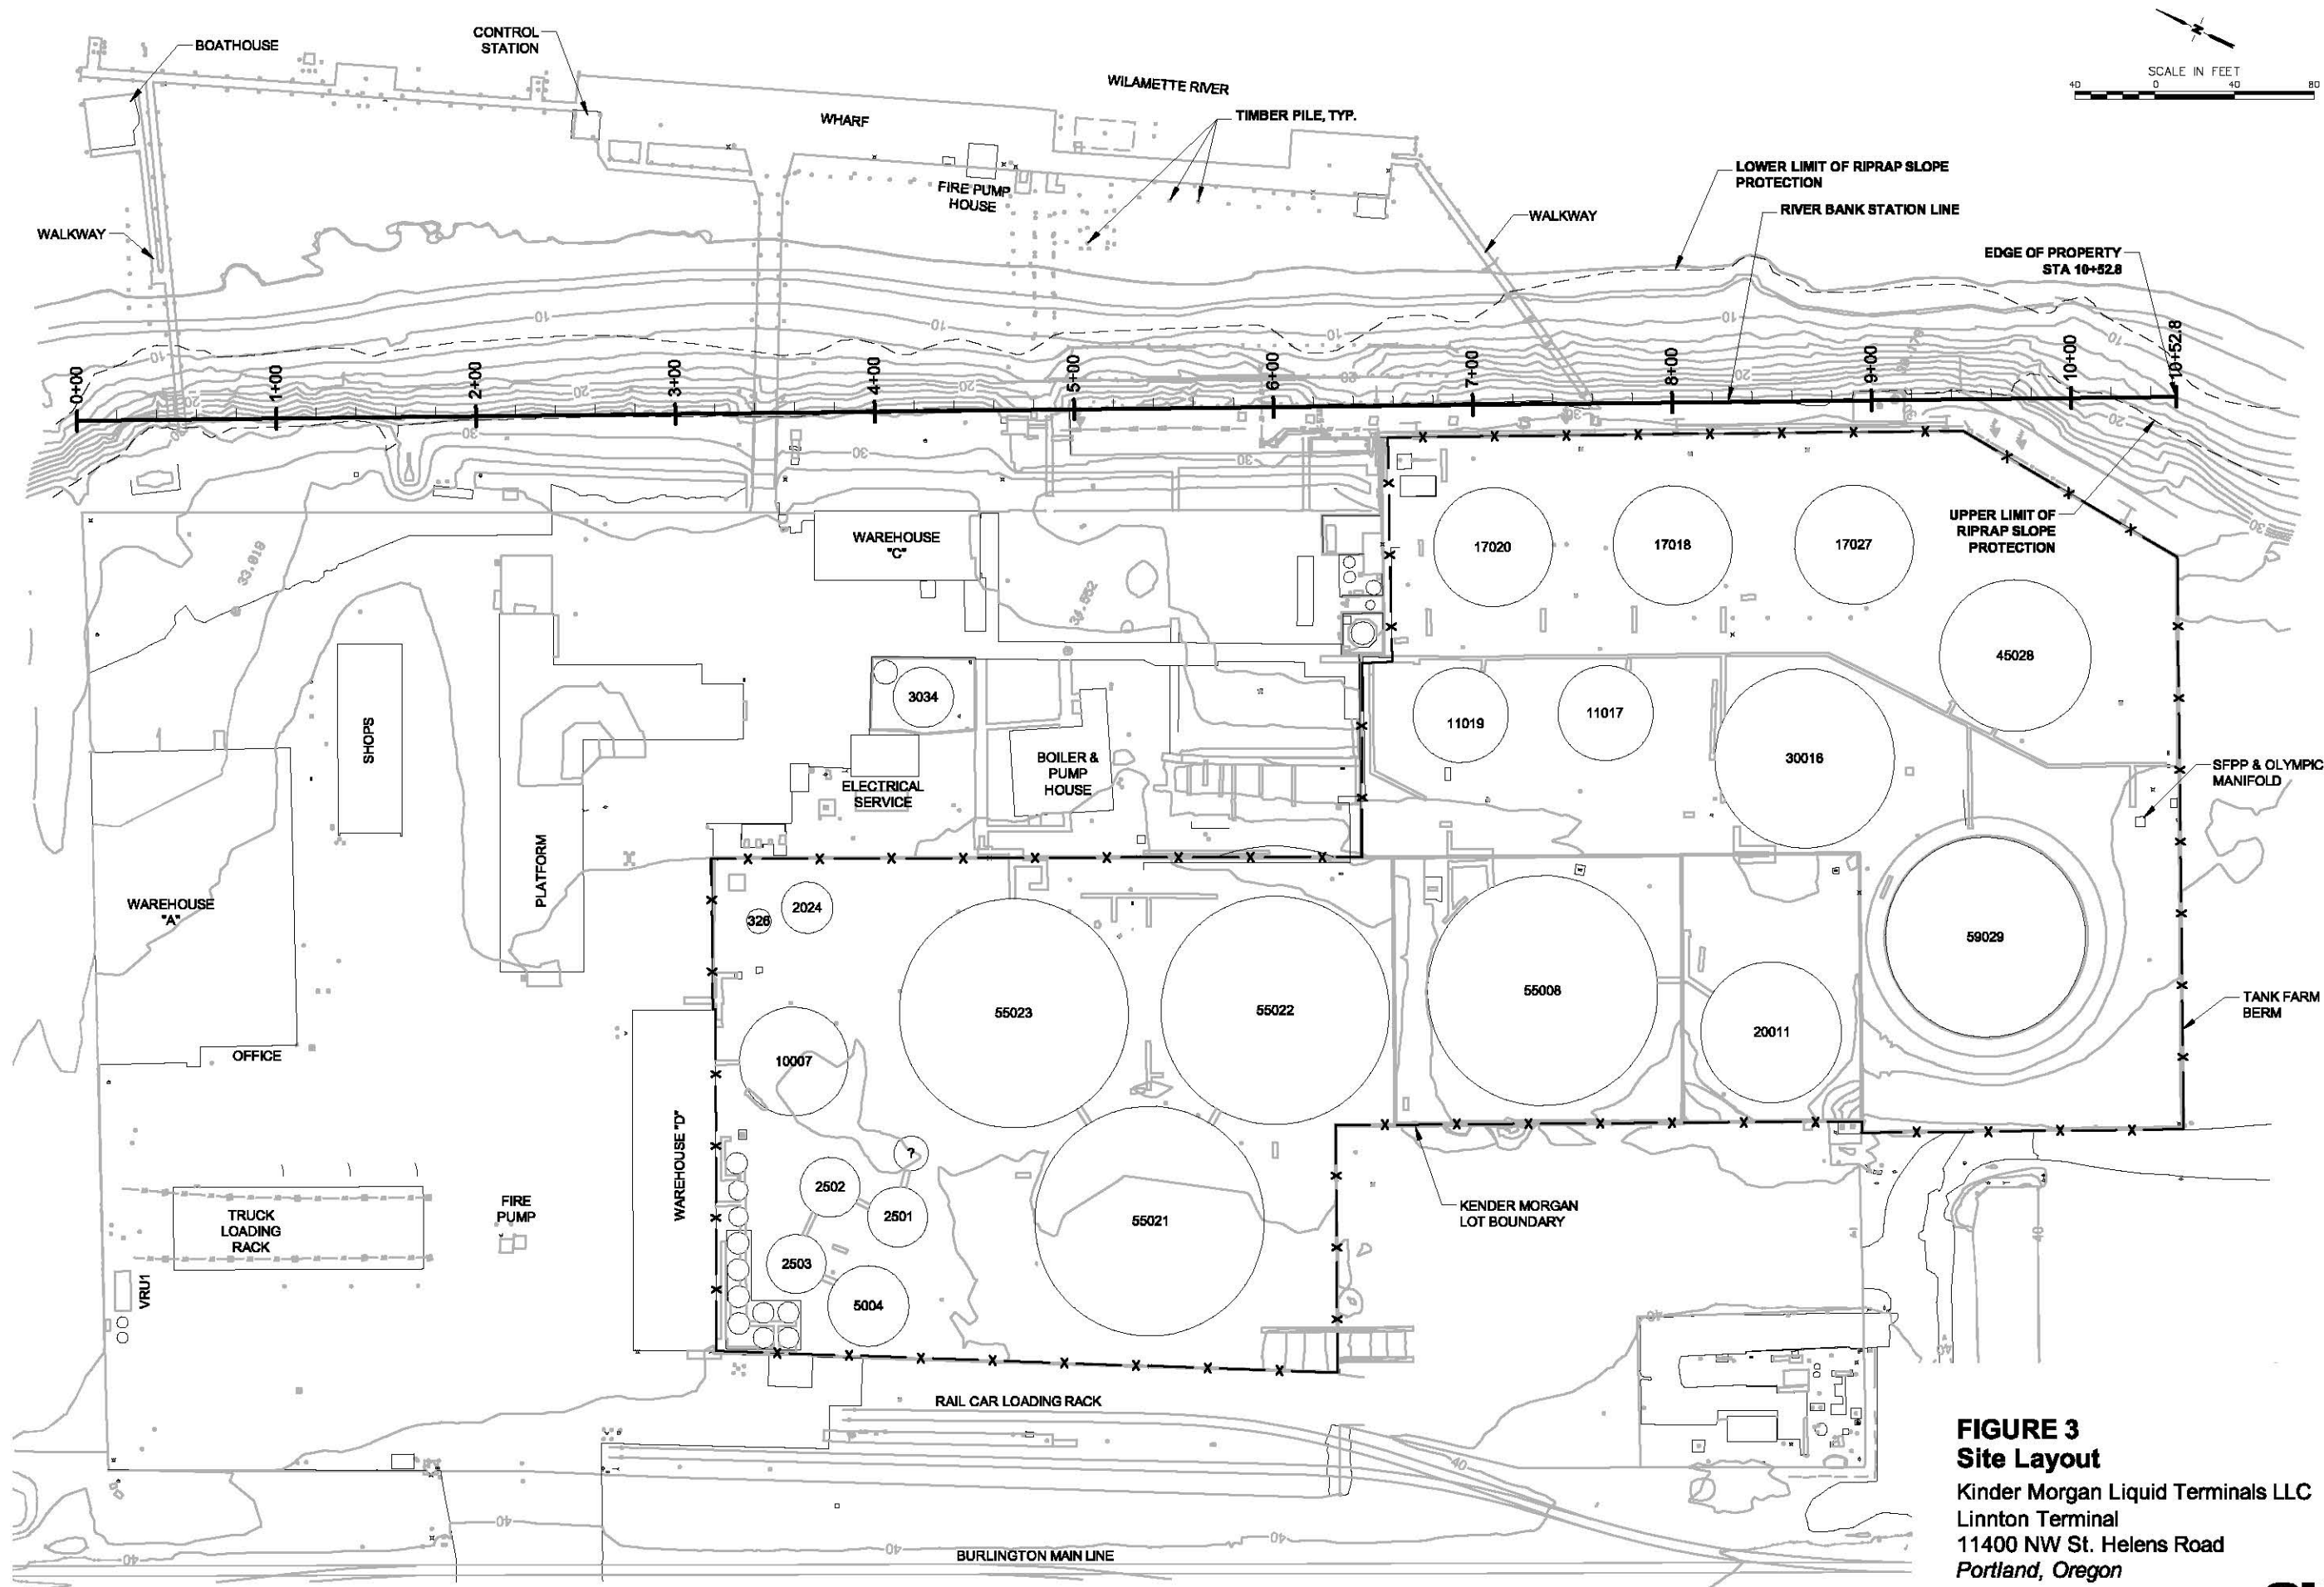
FIGURE 3
Site Layout
Kinder Morgan Liquid Terminals LLC
Linnton Terminal
11400 NW St. Helens Road
Portland, Oregon

There is evidence of minor erosion of the bank in this area from surface water runoff. Surface water appears to collect at the top of the bank and flow around the existing mooring dolphin and over the bank near Station 0+20. The area where signs of surface water erosion was noted is shown in Figure 3.

There is evidence of minor erosion of the bank in this area from surface water runoff. Surface water appears to collect at the top of the bank and flow down the bank near Station 10+00. The area where signs of surface water erosion were observed is shown in Figure 3.

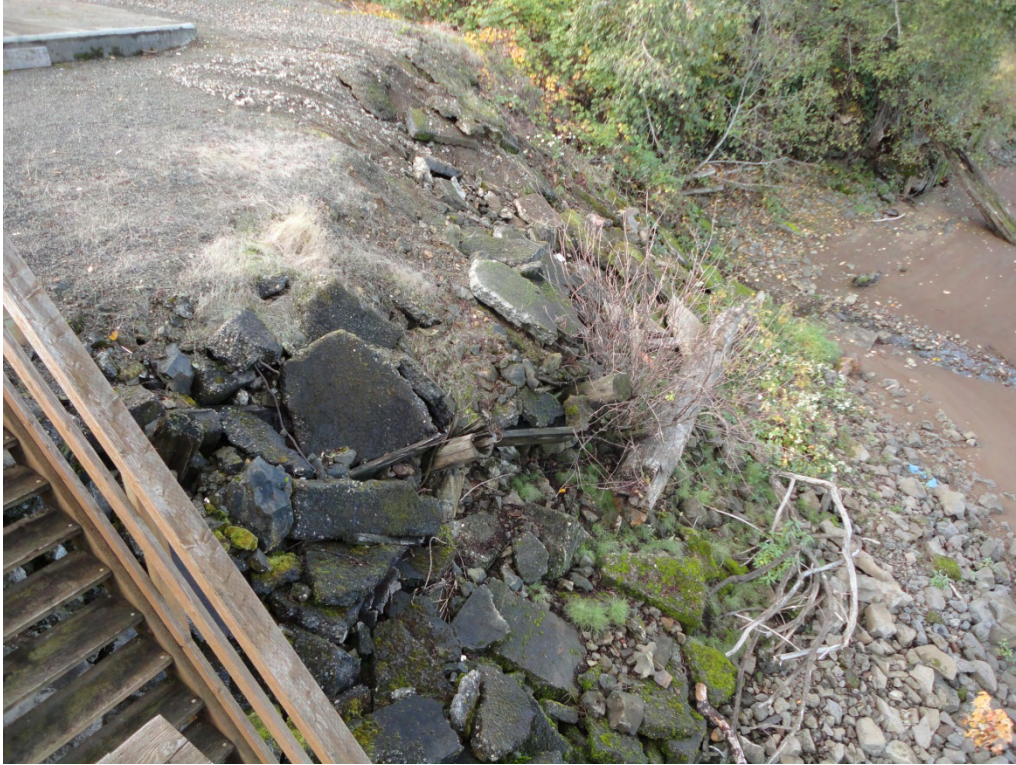
Photograph 3: Station 0+00 to 0+50. Looking down from walkway @ Station 0+50.

The upper portion of the river bank surface along this section consists of rubble fill that includes large slabs of concrete mixed with gravel and soil. The concrete chunks are generally between 6 and 12 inches thick and between 1 and 5 feet in planar dimensions. The bank along this area is very steep, with a few areas that are steeper than 1H:1V. Below about elevation 16 feet, bank material consists of an angular to sub-angular basalt riprap ranging in size from about 24 inches to 4 inches diameter. The medium size of riprap in this area is about 12 inches. This material extends below the bottom of the steep portion of the bank that is at approximate elevation 12. Woody debris and logs are present on top of the riprap at the bottom of the bank.

While the concrete rubble on the upper bank provides protection against some forms of bank erosion, it appears that the material was not placed in a controlled manner and the soil component of the bank material is very loose. Areas of voids are visible beneath some of the concrete slabs. Based on a visual examination, it appears that the soil component of the fill could be subject to erosion during large flood events. The oversteepened sections of the bank may also be subject to minor slumps that could expose new bank material, although it appears that the additional fill material would be present behind the currently exposed fill and that bank erosion would not be extensive.

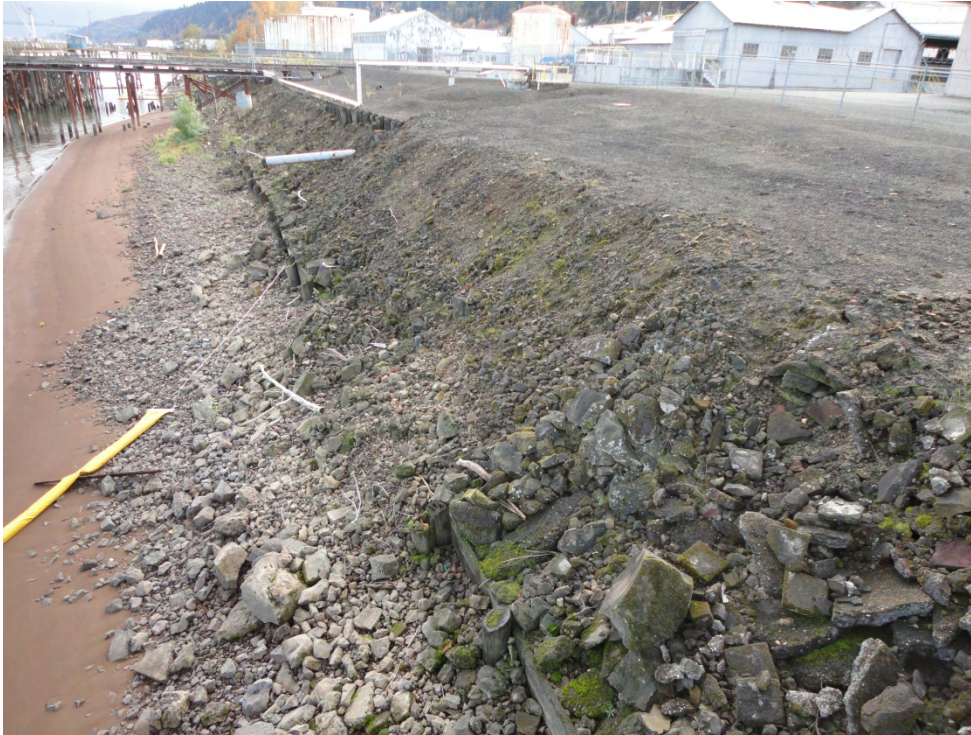
Photograph 5: Station 0+50 to 1+60. Looking south from walkway to dock

The section of river bank between Stations 0+50 and 1+60 is covered by angular to sub-angular basalt riprap from the toe of the bank up to an elevation of 18 feet. The riprap ranges in size from greater than 2 feet diameter to less than 4 inches in diameter with the average size being about 10 inches in most places. The lower portion of the bank is well protected against erosion.

The upper portion of the slope in this area is variable. In some areas relatively large armoring stone (up to 18 inches diameter) protects the upper slope, but in others the largest armoring stones appear to have rolled away from the upper portion of the bank leaving behind a mixture of small cobbles, gravels, and soil. This is the case between approximate Stations 0+80 and 1+40 where the bank between approximate elevation 24 and 30 consist of a mixture of cobbles, gravels, and soil. The slope along this upper steep portion of the bank is approximately 1H:1V. The lower portion of the bank has a slope between 2H:1V and 2.5H:1V.

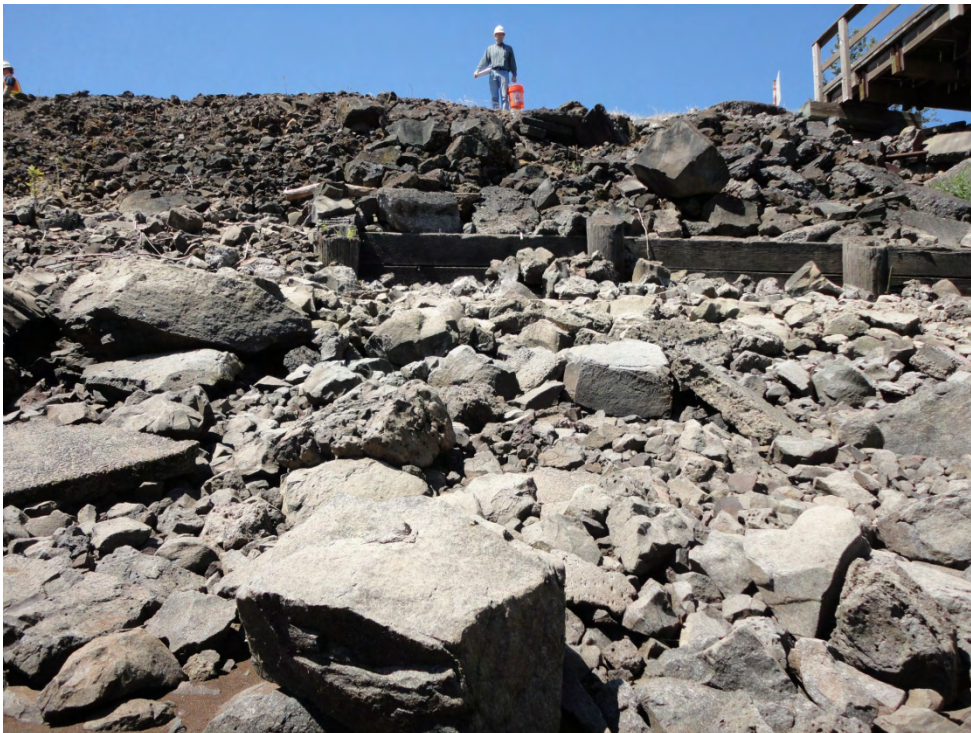
Photograph 6: Station 0+75 Looking up bank from bottom of slope.

The upper row of timber pile bulkhead is not visible along most of this section. Four to five timber piles are visible at the ground surface between Station 0+80 and 1+10, but they are flush with the ground surface. It appears that surface water from the terminal facility flows over the portion of the bank between approximate Stations 0+80 and 1+40 during heavy rain events. There are no signs of concentrated flow therefore it's expected that any flow occurs in sheets. Consequently, there is no major erosion from surface water runoff.

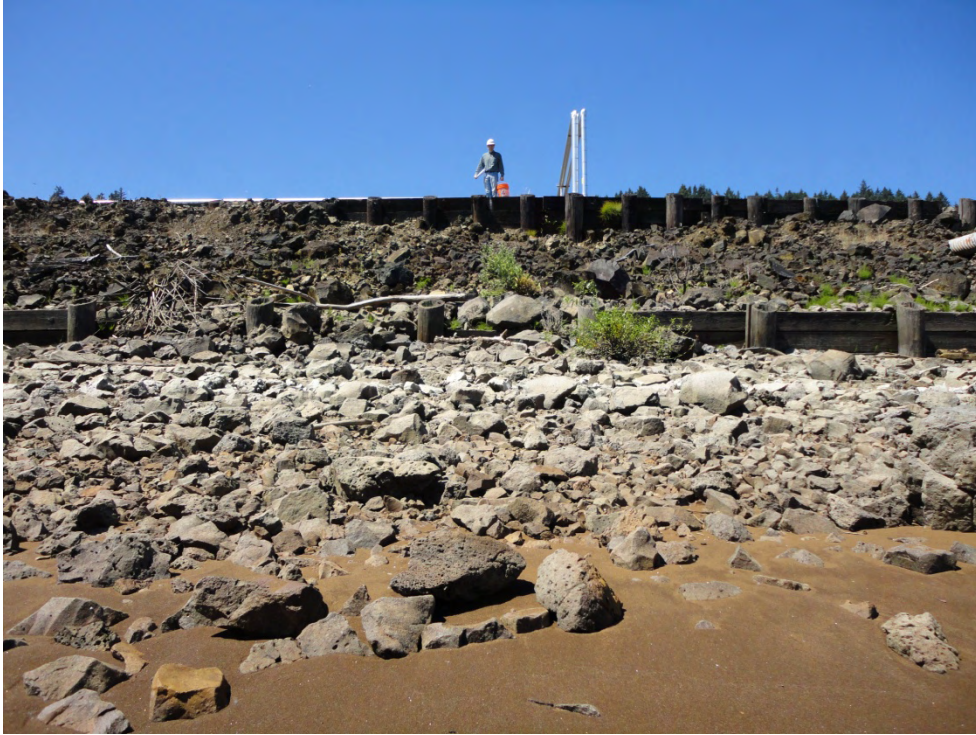
Photograph 9: Station 2+00. Looking up bank from shore of river.

The section of river bank between Stations 1+60 and 4+70 is similar to the section between Stations 0+50 and 1+60. The major difference is that the upper bulkhead is present and continuous along this section of the site and that the riprap armoring along the upper portion of the slope has remained in place over most of the bank. There are only small and isolated areas where some of the larger riprap appears to be missing from the upper sections of the bank between elevations 26 and 30 feet.

The upper bulkhead limits the potential for surface water to flow over the bank. There are no signs of erosion from surface water flowing over the bank in this area.

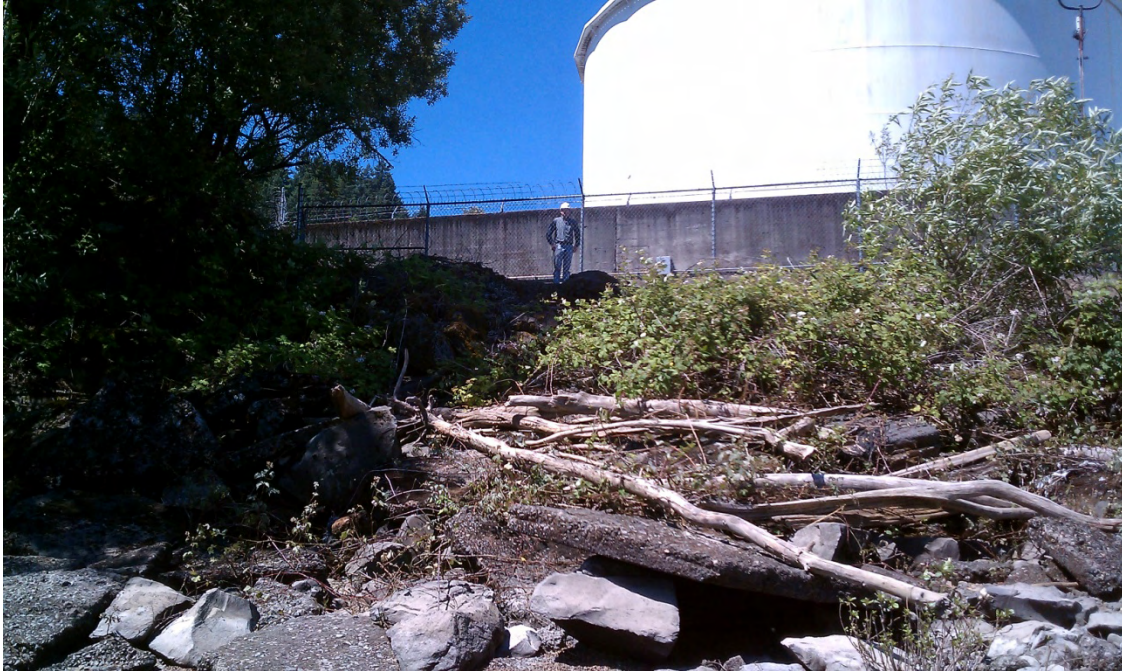
Photograph 22: Station 10+40 Looking up bank from bottom of slope.

The lower portion of the river bank between approximate elevations 10 and 18 and between Station 9+70 and the south end of the property is covered with basalt riprap having similar characteristics as those described for Station 6+80 and 9+70 (above). The portion of the bank above this elevation consists primarily of sand and gravel with occasional cobbles and boulder-sized riprap pieces.
